Service Technical Information

MODEL NO. CSD-MD5/MD30/MD50/MD70
SUBJECT MD unit does not operate (mechanism lockup)

REF.No. :G - A0 - 050 - E0

DATE :07. JUL. 2000

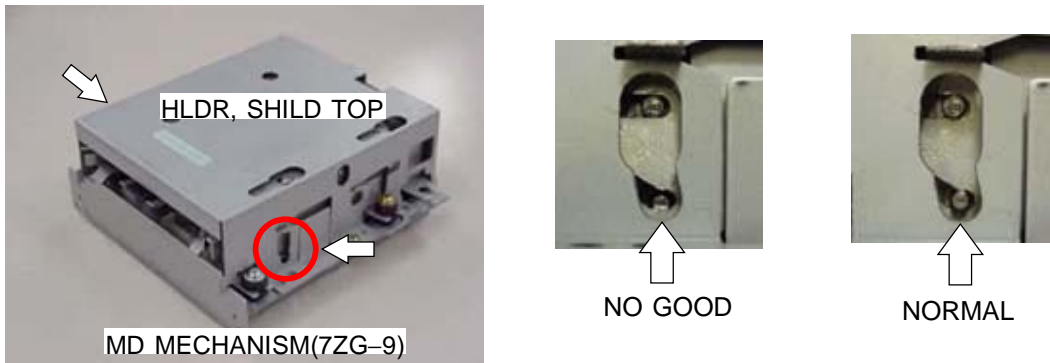
On the models concerned, MD mechanism (7ZG-9) is locked up and completely disallows any operations. Take the following actions against the problem.

Verify that the pins of MD mechanism (7ZG-9) indicated with arrows in the figure fit into the slits properly.

If the pins are off the slits, return the pins to the slits and then replace HLDR, SHILD TOP.
