# Service Technical Information

MODEL NO.	XR-MD85 EZ
SUBJECT	Tape stop at FM recording

REF.No. :G - 99 - 047 - E0

DATE :01. NOV. 1999

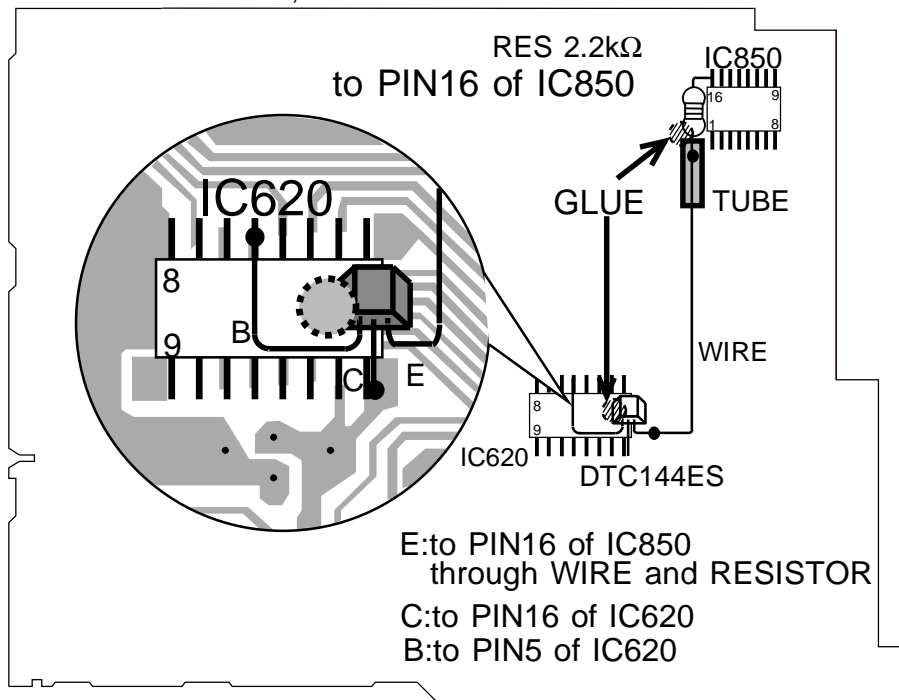
## MAIN C.B. PATTERN SIDE

A tape stops in approximately 5 minutes after starting recording of an FM program on tape, using the model in question.

This problem occurs when an FM signal includes RDS signal.

1. Solder the base terminal of DTC144ES to pin 5 on IC620, and solder the collector terminal of DTC144ES to pin 16 of IC620.
2. Solder the emitter terminal of DTC 144ES to the wire, and let the wire in the tube.
3. Solder an end of the wire to the resistor.  
Solder the other end of the resistor to pin 16 of IC850.
4. Lock DTC144ES onto IC620, and lock the tube and the resistor onto the main C.B. with glue.

After taking the above actions, RDS indication will not be updated during REC operation on tape.
