Service Technical Information

MODEL NO. AM-F70 / F65
SUBJECT Changes of component values in motor-drive circuit

REF.No. :G - 99 - 079 - E1

DATE :30. AUG. 2000

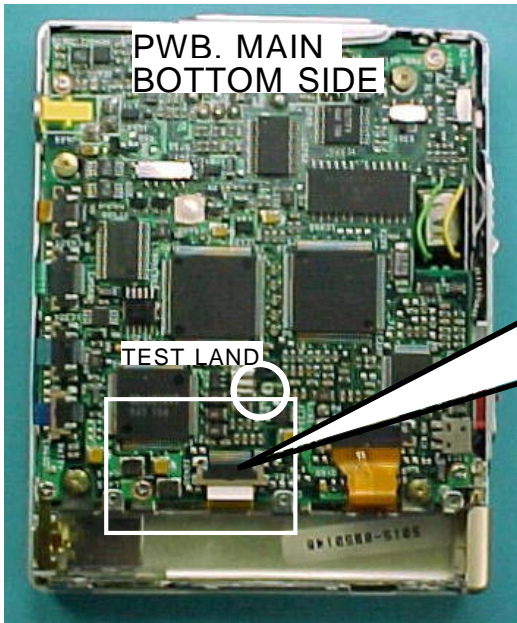
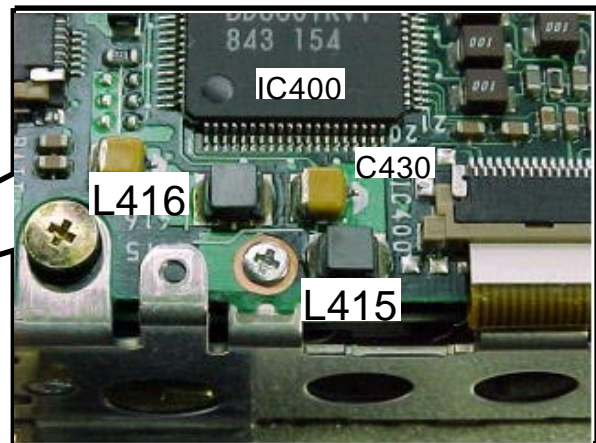
A fault may occur in IC400 or C430 of the models concerned.
 For avoiding the fault, component values of L415 and L416 shall be changed.
 L415 100 μ H \rightarrow 330 μ H , L416 47 μ H \rightarrow 100 μ H

- 1) Remove L416 (47 μ H).
- 2) Remove the coil of L415 (100 μ H), and mount the coil onto the land of L416.
- 3) Mount a 330 μ H coil onto the land of L415.
- 4) Start the TEST MODE (P-ON with the SYNCHRO SW set to OFF), and confirm the SLED operation of the pick up by pressing F-SKIP and B-SKIP.
 - The countermeasure is complete if the SLED operation of the pick up is smooth.
 - If the SLED operation of the pick up is not smooth, change L416 back to 47 μ H.
 Complete the countermeasure after checking again that there is no abnormality in the SLED operation of the pick up.

The 100 μ H coil used on L415 will be mounted on land of L416.
 Order a 330 μ H coil only.
