# Service Technical Information

MODEL NO. XR-H66MD
SUBJECT MD does not operate

REF.No. :G - A0 - 072 - E0

DATE :22. SEP. 2000

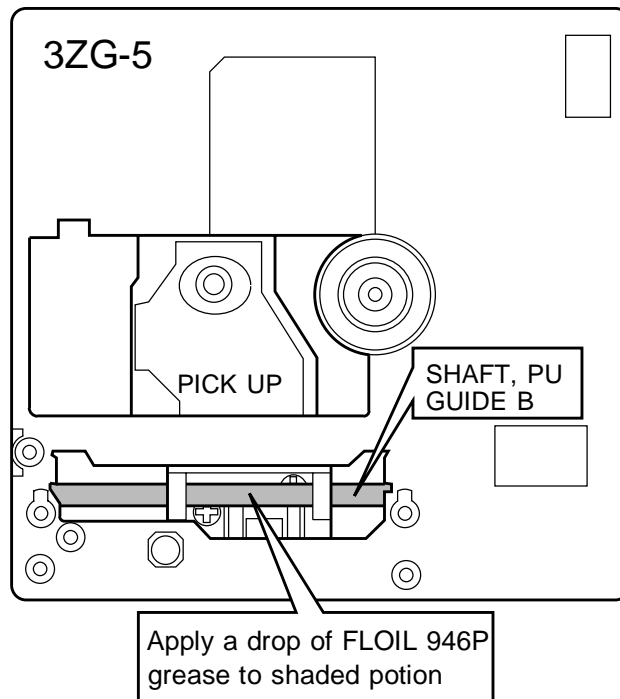
The MD mechanism does not operate because of a PICK UP locking onto a shaft.  
Take the following action against the symptom.

- 1) Remove SHAFT,PU GUIDE B from 3ZG-5.
- 2) Clean the shaft bearing of the PICK UP.
- 3) Replace SHAFT,PU GUIDE B with new one.
- 4) Apply grease (FLOIL 946P) to specified potion of the shaft.  
(Then, move the PICK UP a few times for lubrication.)

If movement of the PICK UP does not become smooth even after the treatment above, replace the PICK UP with new one.
