SONY® Service Bulletin

NO: ME3-99-004

SUBJECT: DISC NOT BEING CHUCKED, OR WHEN PUSHING EJECT, DISC CANNOT COME OUT

MODEL (S): MDX-C670/C7900/C8900

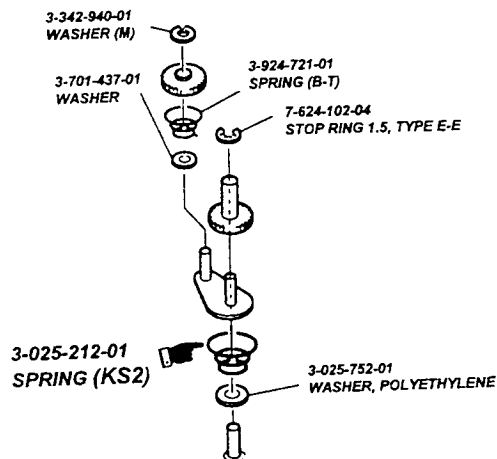
SYMPTOM: The disc is inserted and may not chuck, due to insufficient friction torque of lever (S) assembly. Pushing eject may cause this symptom.

SOLUTION: Please add the spring (KS2)/service assembly kit to lever (S). See illustration for detail.

DESCRIPTION	PART NUMBER
SPRING ASSEMBLY (KS2) ASSY	X-3376-538-2
GEAR (S)	3-919-315-02
