Service Technical Information

MODEL NO. CSD-MD50
SUBJECT Clock becomes loses only in ECO mode

REF.No. :G - 99 - 054 - E0

DATE :08. NOV. 1999

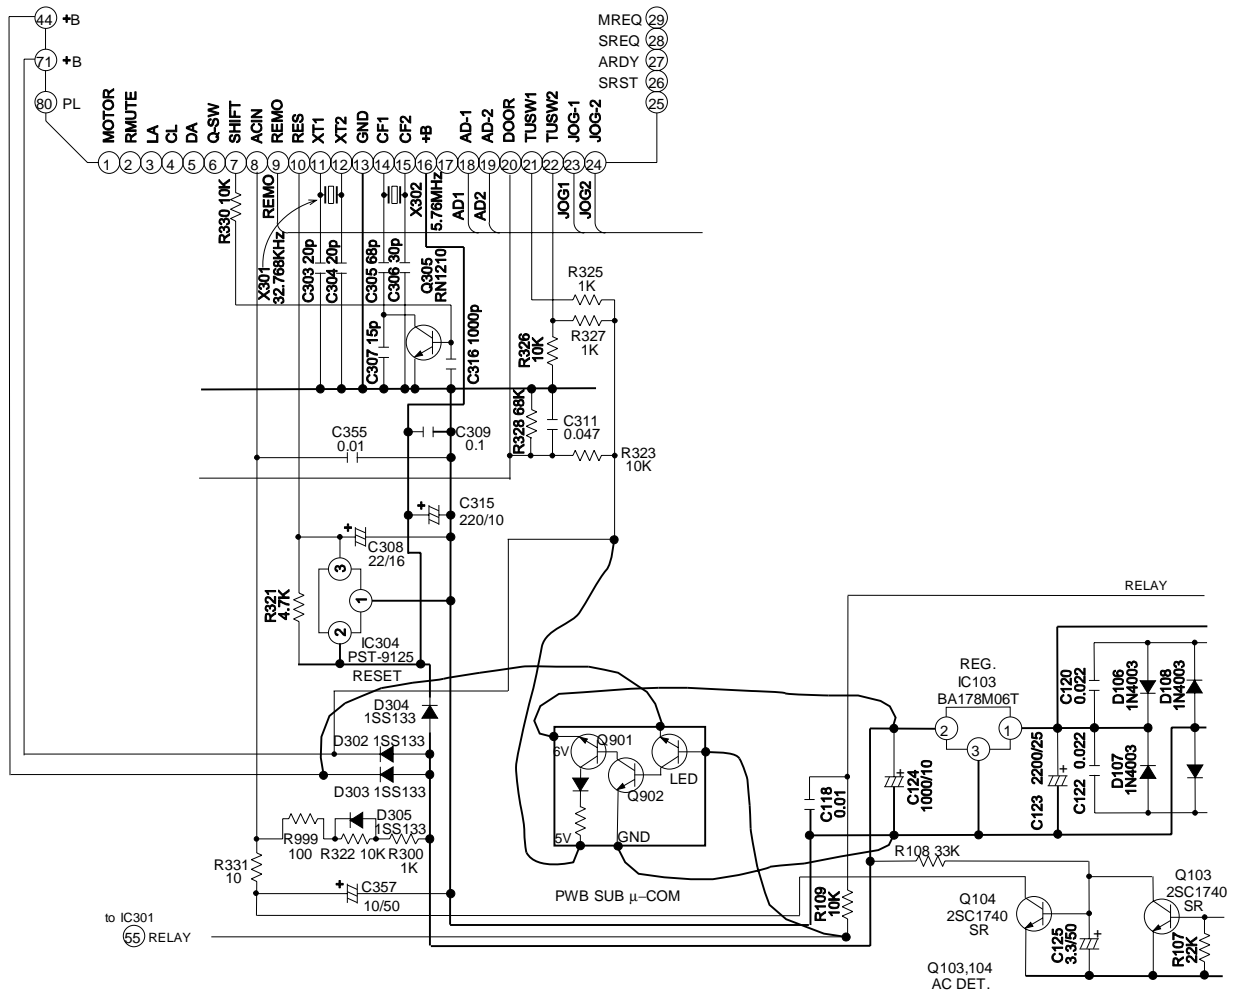
In ECO mode, the system clock becomes loses by one minute per day under standby status.

Take the following steps as shown in the figure below:

- 1) Remove the resist (a) off the P.W.B μ -COM/CD using a knife, etc.
- 2) Solder five wires of a repair P.W.B. SUB μ -COM.
- 3) Cut a cushion in half, and stick a piece of it on the P.W.B. SUB μ -COM.
- 4) Stick the P.W.B. SUB μ -COM with cushion onto the P.W.B μ -COM/CD. (on IC502 section).
- 5) Gather the wires and fix them down with CLOTH.
- 6) Lock down the P.W.B SUB μ -COM with glue (1600B) at four points.
