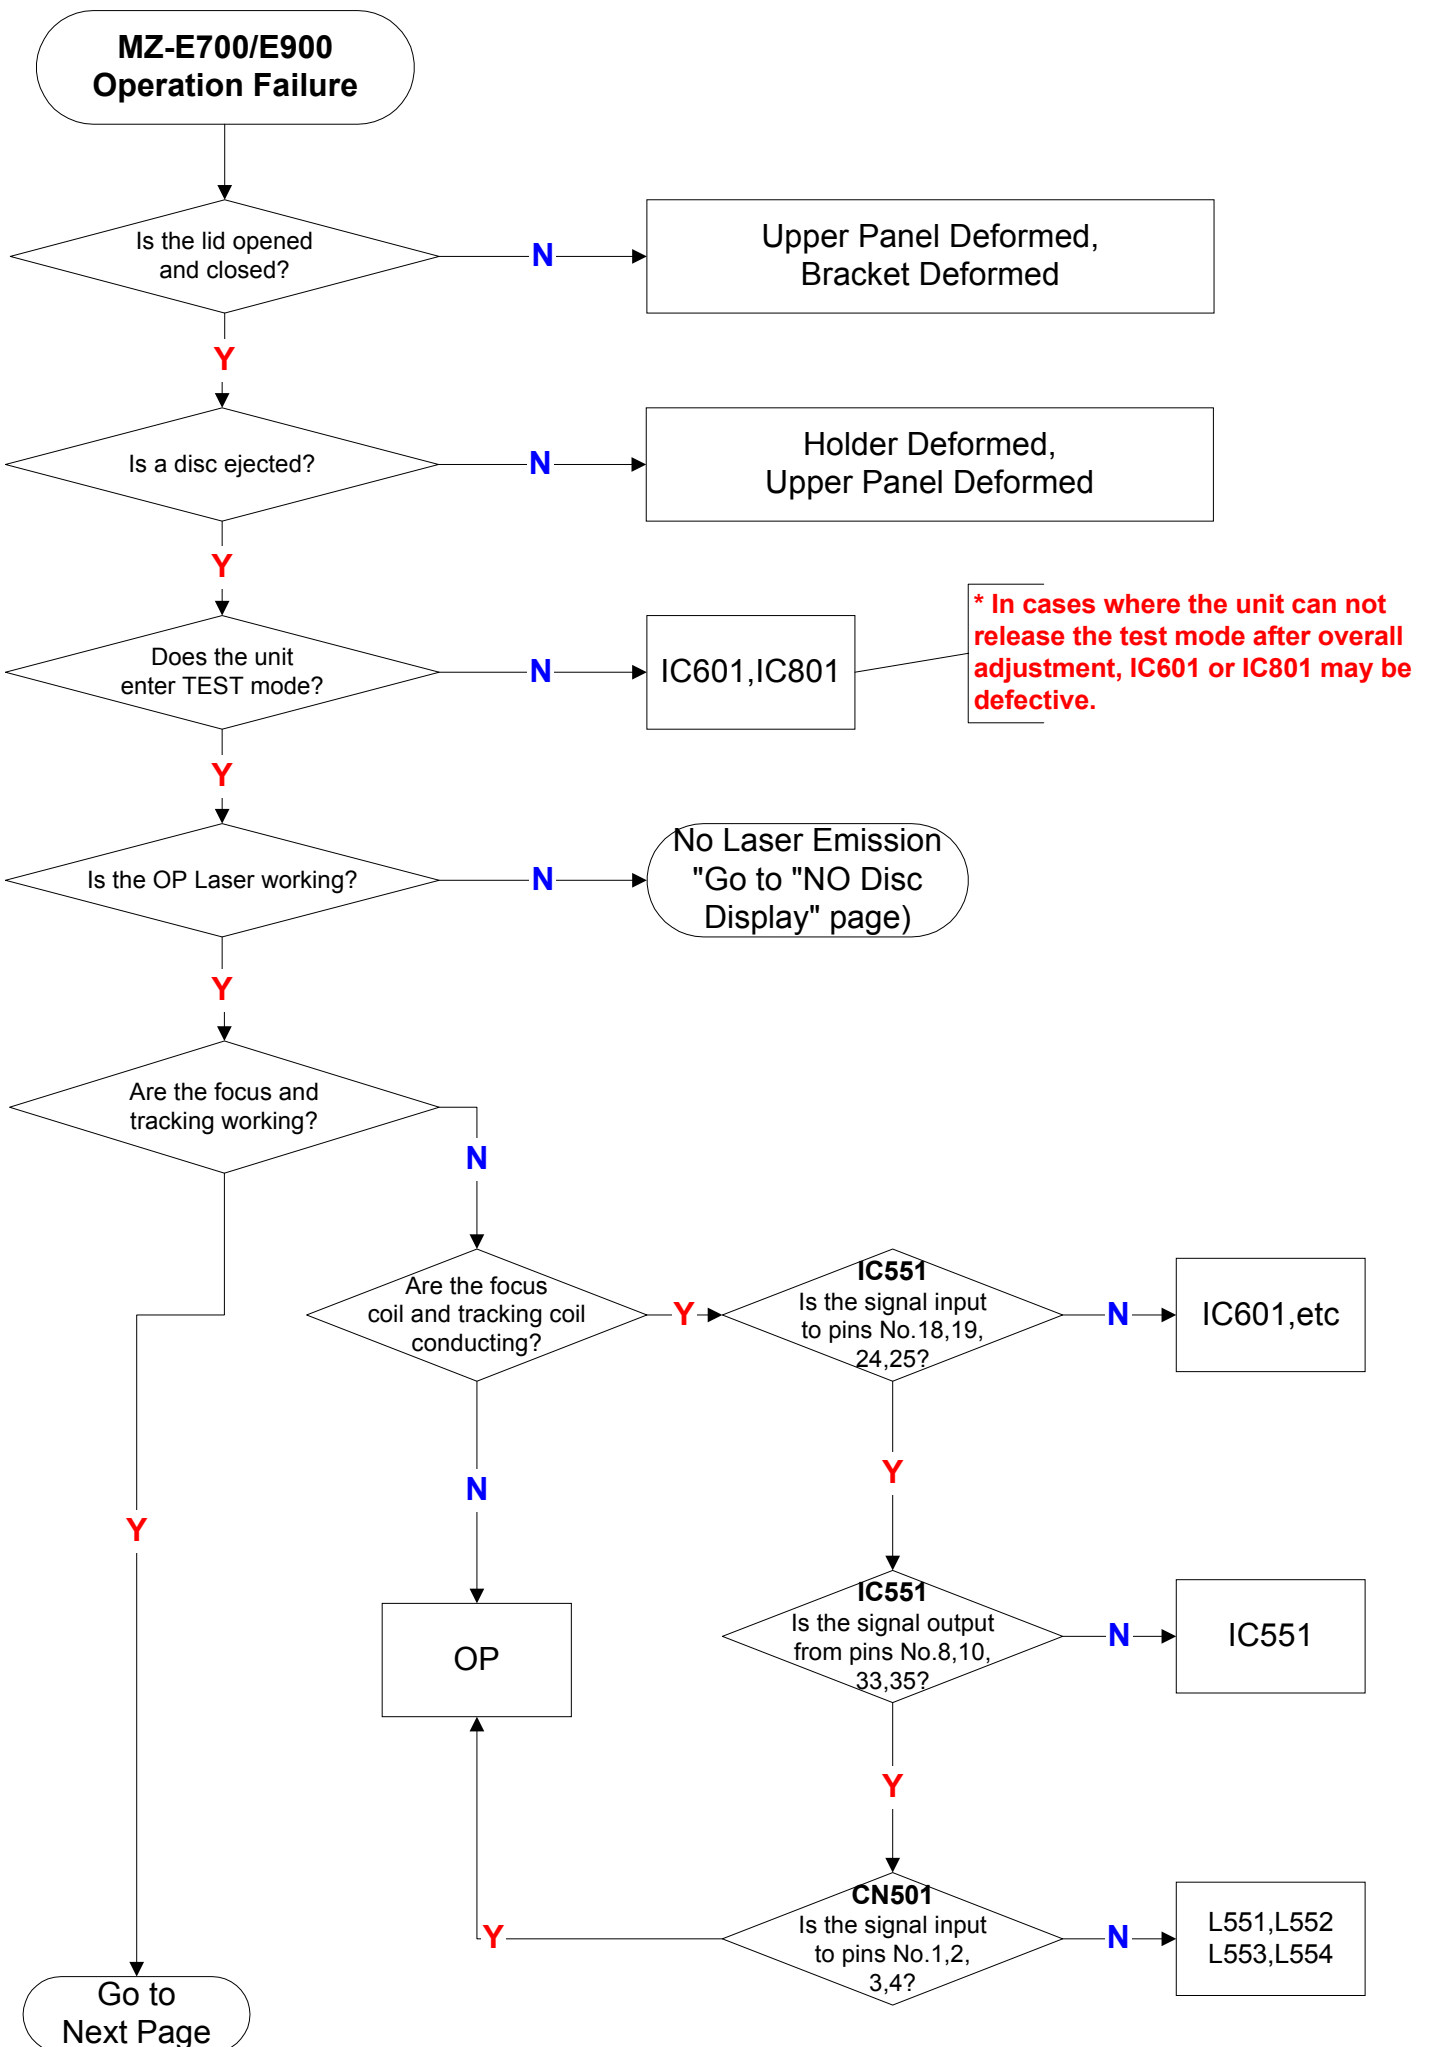
*** If a strong shock is added to the unit, track patterns of CSP(IC601) are more likely to be peeled off and also a cold solder is easily occur on IC551.**

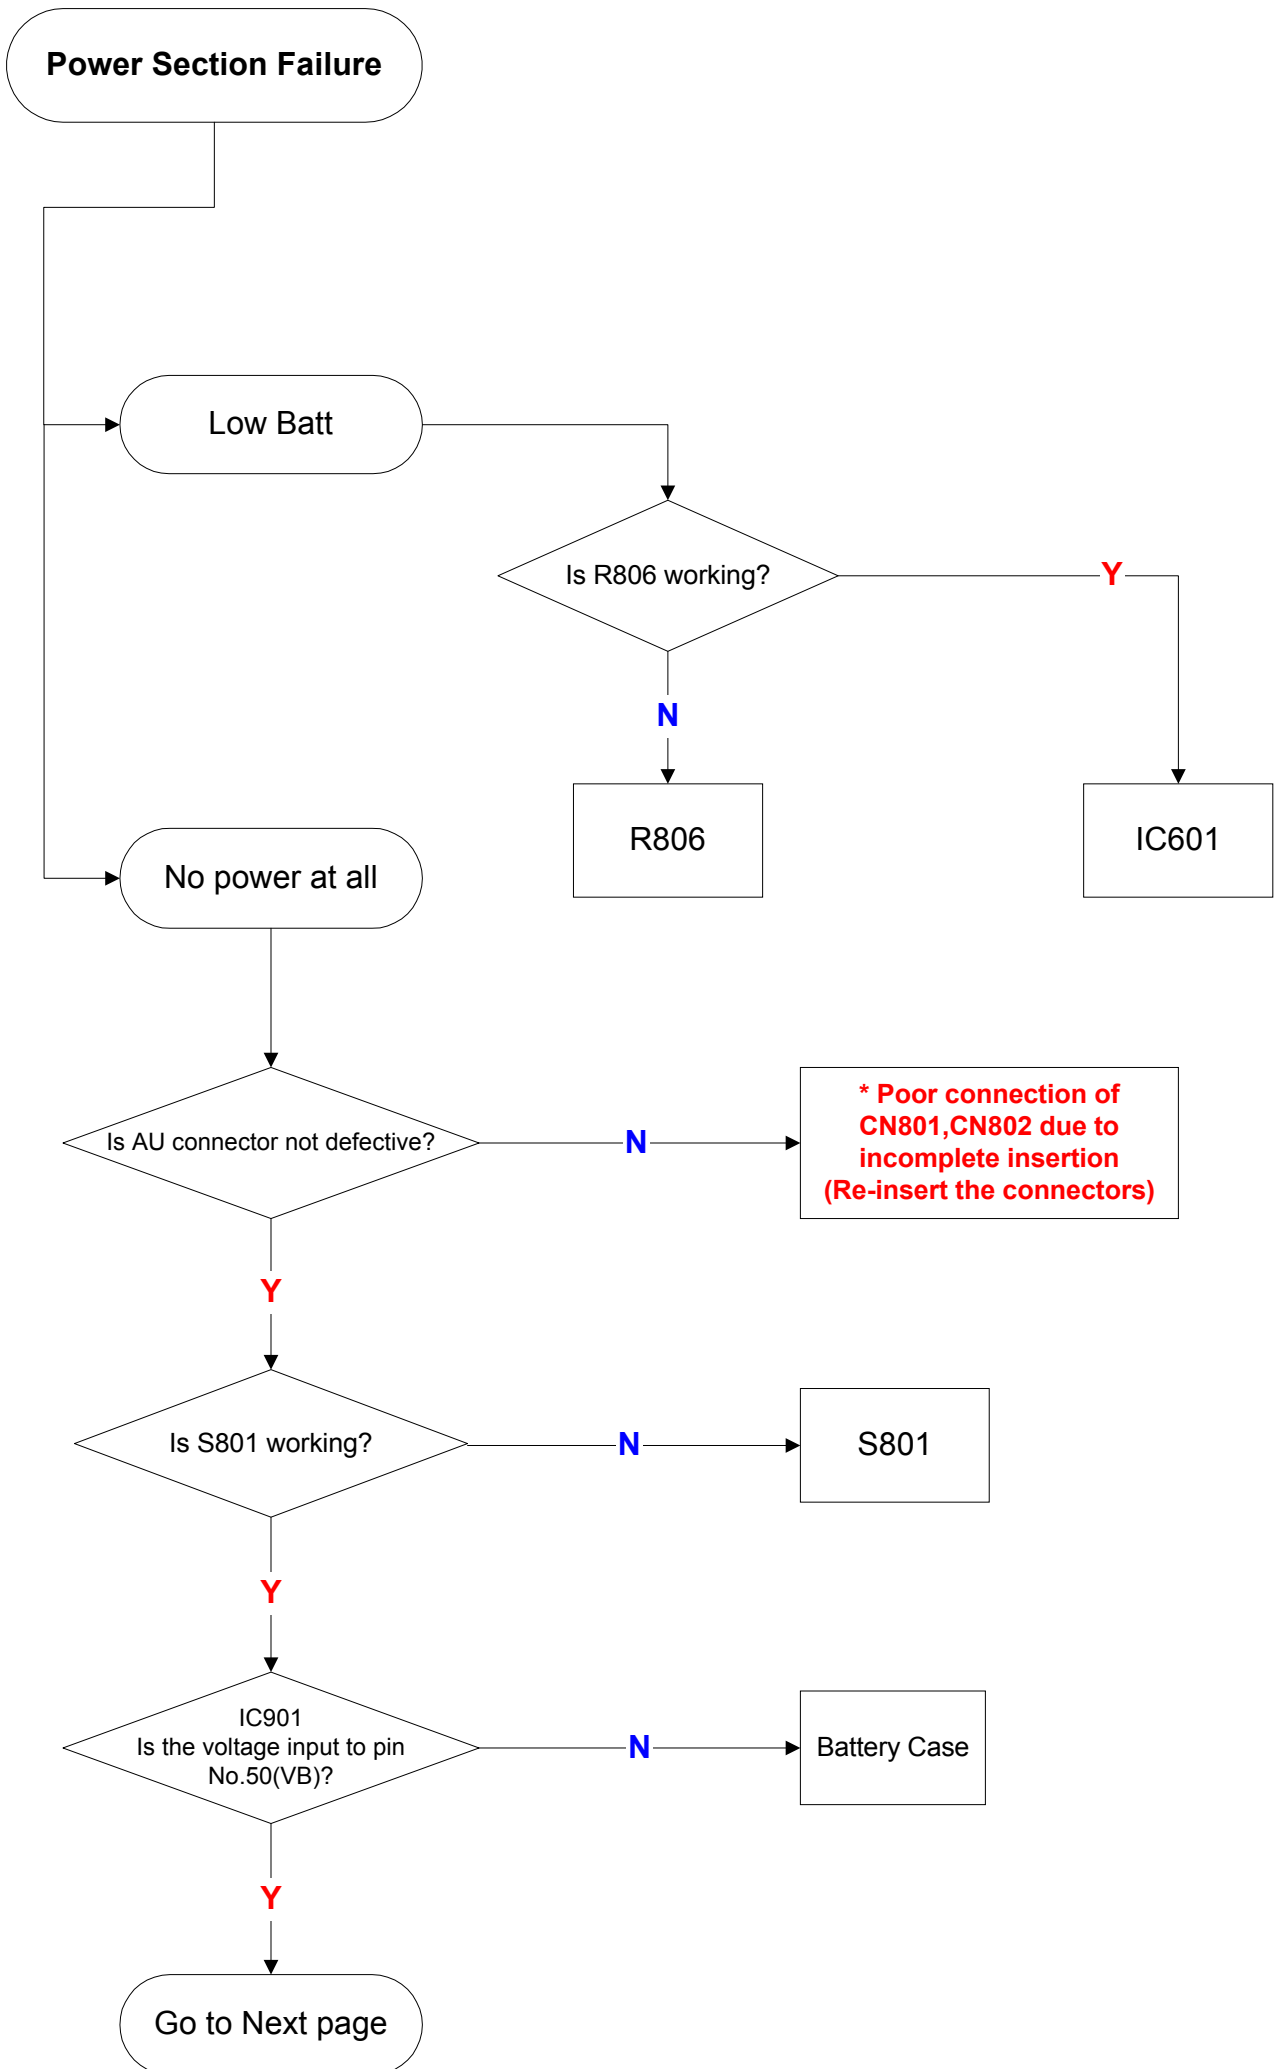
* Cold solder or peeling of IC901, IC601 are more likely to occur for dropped units.
