Service Technical Information

MODEL NO. AM-HX50 / HX55
SUBJECT Come off screw of HP JACK

REF.No. :G - A0 - 011 - E0

DATE :27. APR. 2000

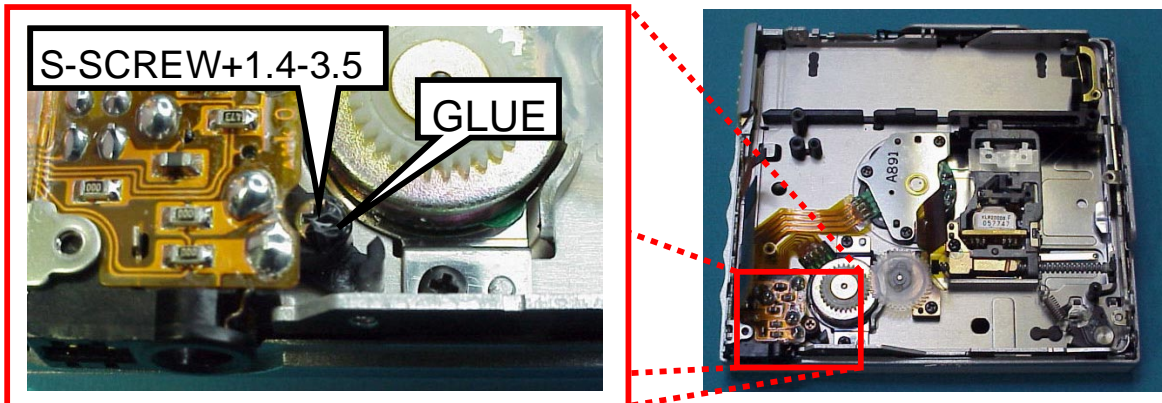
For the above mentioned products, the screw holding the HP JACK are occasionally lost. When this screw dislocate, it attach to the spindle motor or to the magnets of the PICK UP, causing possible NO PLAY. Complete the following procedures when the screw is missing. And also complete the following procedures when the screw is taking out during repair.

Replace the screw holding the HP JACK with the Parts Code listed below and glue it on. Use glue No. 1600B(No.1620B).

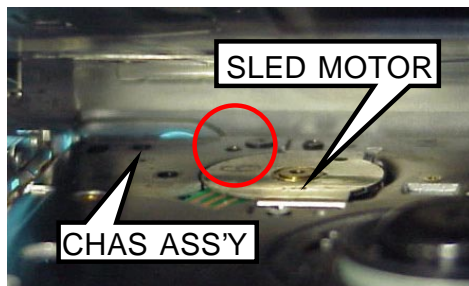
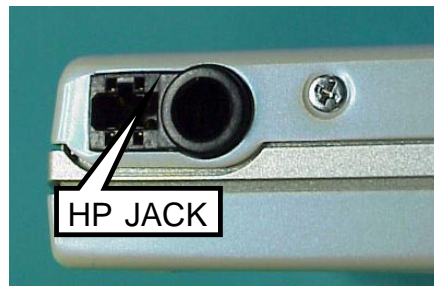
1. Don't fasten too tightly the screw to fix the HP JACK.
 - (1)Be sure that the screw don't protrude from the chassis.
 - (2)Be sure that stress is not applied to the HP JACK.

- 2.Don't get glue on the sled motor or gears.
