Service Technical Information

MODEL NO.	AM-HX50 / HX55
SUBJECT	Loose PICK UP prism Warnings when replacing PICK UP

REF.No. :G - A0 - 012 - E0

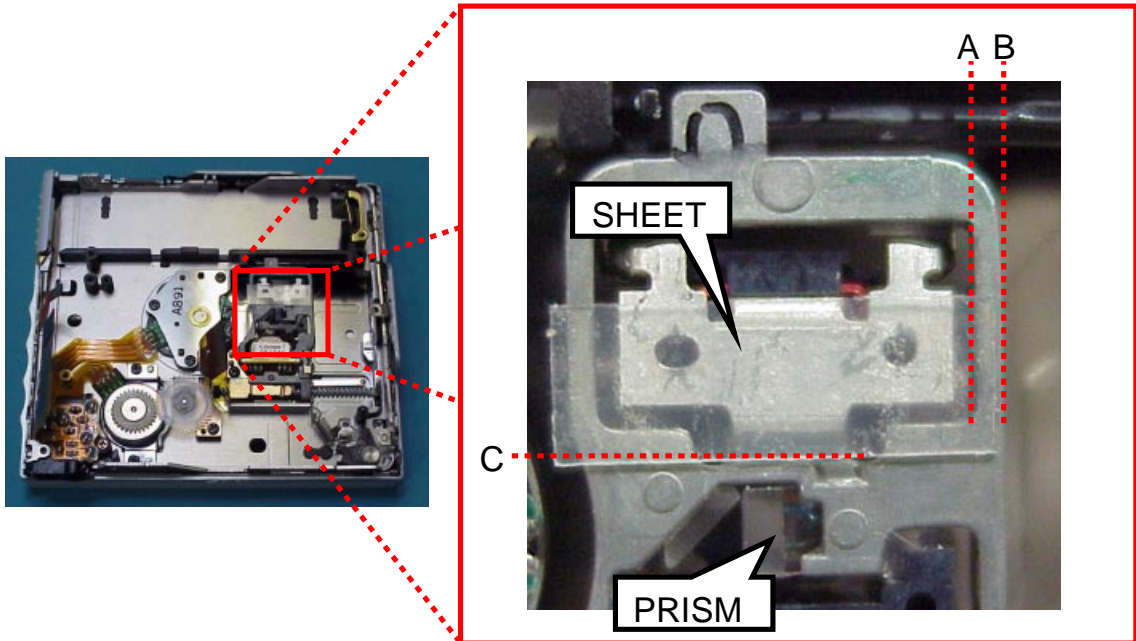
Due to loose prism PICK UP, "NO DISC" may be displayed when playback is desired.
Complete the following procedures when this occurs.
Also, complete the following processes even when PICK UP is replaced in cases other than loose prism.

Affix the sheet to the bottom surface of the PICK UP after replacement.
Align a corner of the sheet with line C so that the sheet sticks on between lines A and B.

Be sure that it does not protrude beyond line B (PICK UP).
Don't touch the prism.
