Service Technical Information

MODEL NO. AM-F70 / F65
SUBJECT "Caution!" display appears.

REF.No. :G - 99 - 019 - E0

DATE :02. JUN. 1999

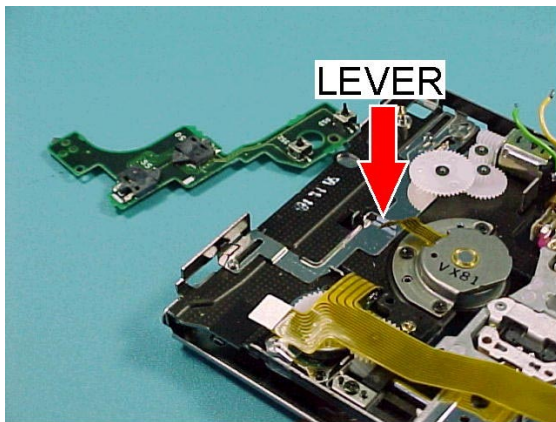
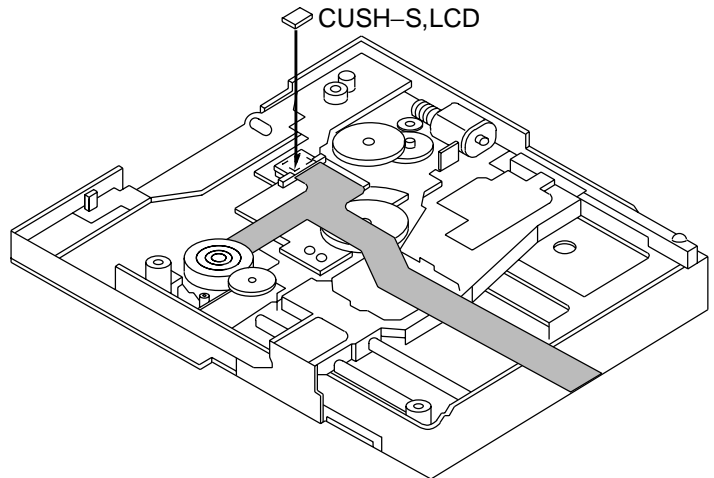
Fig. 1

- If the lever runs on to OWH UP SW(S50) (See Fig.1):
 Remove the lever away from the switch, and then affix a cushion (CUSH-S, LCD) on to the connector of PWB, MECH (CN50).

The "Caution!" display may appear upon turning on the power of the unit or upon attempting REC operation.
 The symptom, however, may not be replicated during verification of operation.
 If that is the case, replace the two switches, S50 and S51 with new ones.
